How to reduce craters in the painting process of a PIM company?

Dept. of Industrial Engineering, Federal University of Amazon (UFAM)

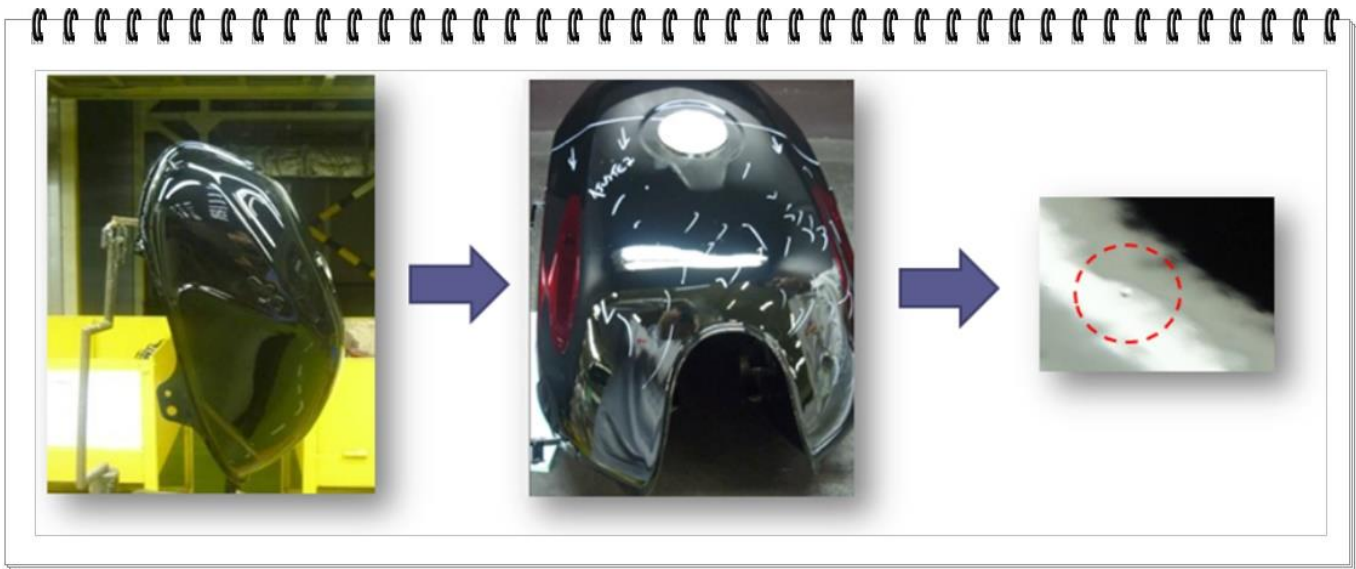
Figure 5: Crater defect feature

The defect occurred in all fuel tank models and all colorings, and in black coloration models, the defect was clearer. One of the characteristics observed was that the crater always occurred at the top of the tank, as can be seen in Figure 5.

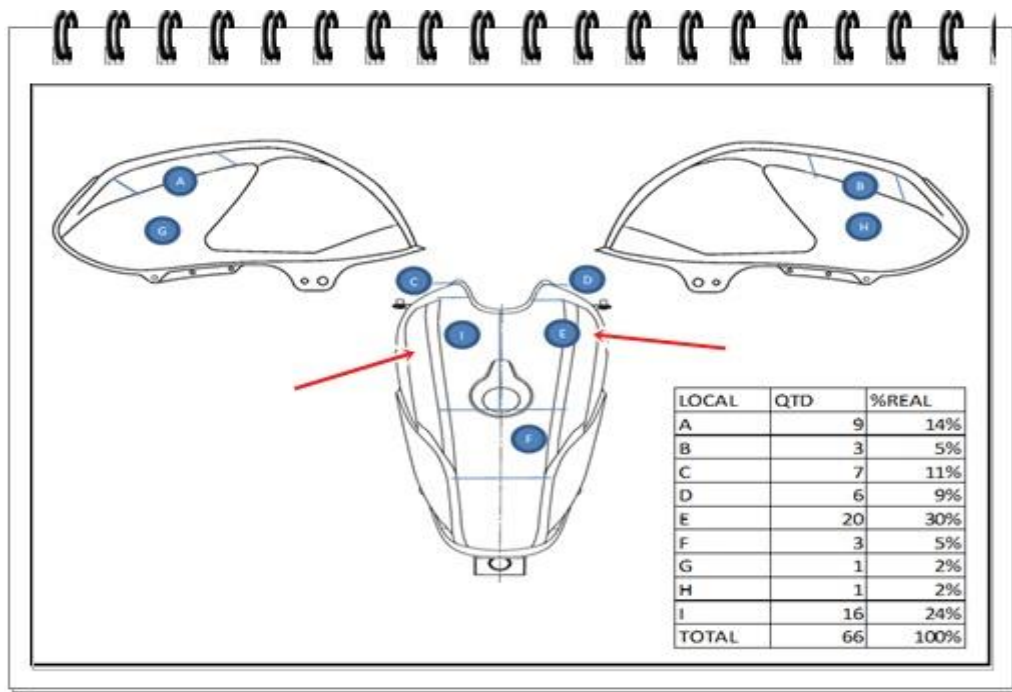
Figure 6: Fuel Tank Pictographic Analysis

A pictographic analysis of the fuel tank was made, where 10 varnished pieces of random models and colorings were analyzed. The amount of defect per piece was found to be an average of 66 craters, concentrated in regions I and E, as shown in Figure 6.

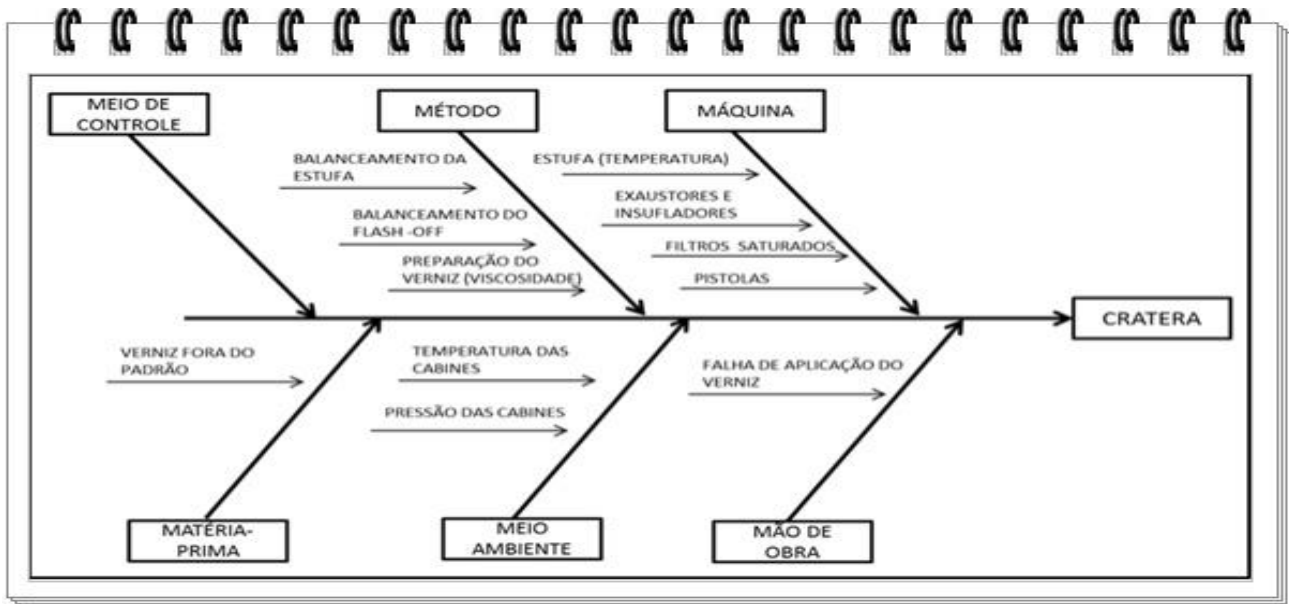
Figure 7: Potential Causes of Crater Defect

According to observations made and the staff's experience of the painting process, eleven possible causes

were raised for the problem as illustrated in Figure 7.

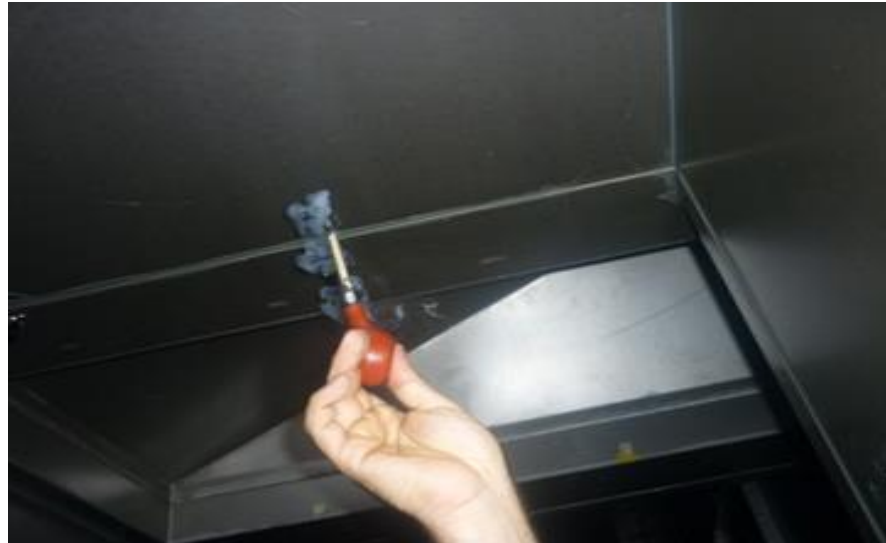
Figure 8: Air Balancing Analysis

The second step was to analyze the air balance within the flash-off generated by the Insufflator and Exhaust. For this, a tool was used that generates smoke less dense than air, allowing to verify its direction (Figure

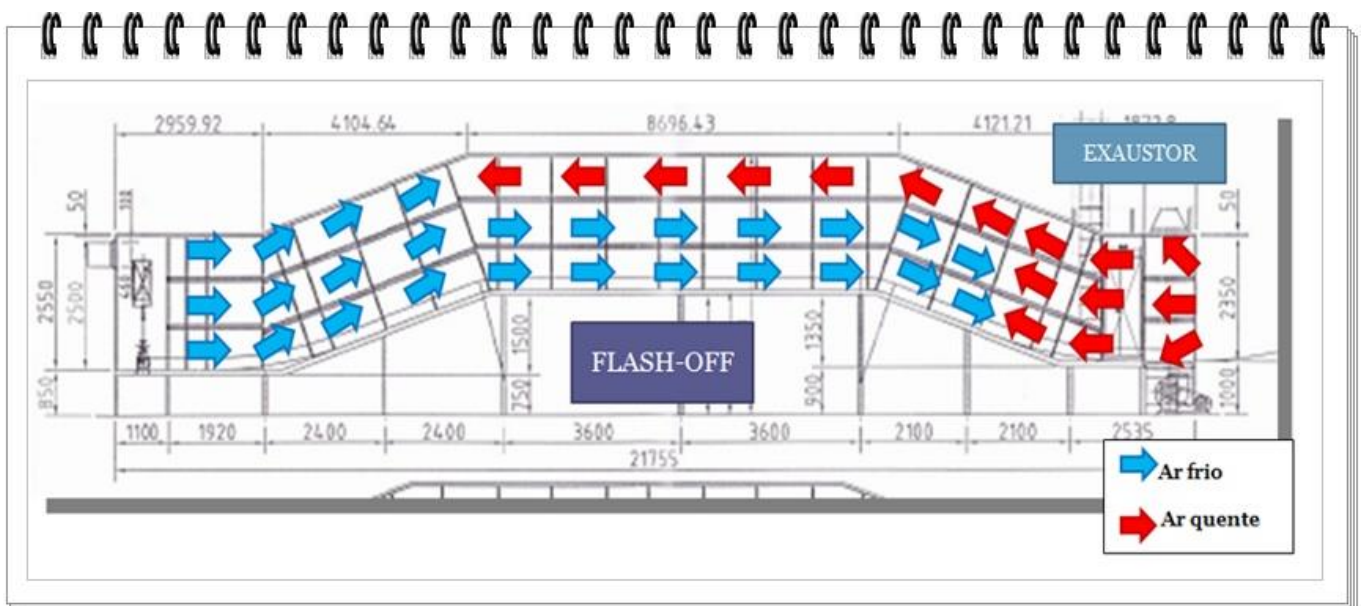
Figure 9: Air balance inside Flash-off analyses.

After monitoring the variables related to the Painting and Preparation Booths of Varnish, Greenhouse, Insufflator and Exhaust Fan, the data collected was analyzed. Inside the Prep Booth, the temperature was within standard and it was found that the viscosity of the varnish was within that specified by the supplier. In the Paint Booth, the room temperature was also within the standard, the painters were applying the varnish as specified and the gun setting was correct. The humidity and air velocity did not show any abnormality inside the booth and the temperature inside the greenhouse was as determined. Regarding the balance within the flash-off, it was verified that the hot air generated by the greenhouse was entering the flash-off, as shown in Figure 9.

From this analysis, a hypothesis was raised for the appearance of the crater defect. The warm air from the greenhouse being less dense than the cold air would flash in from the top and this would cause the tank varnish to heal faster in the upper region.

Thus, when passing through the greenhouse, the upper region of the tank would have greater difficulty in releasing the solvents contained in the varnish, thus generating the craters.

Upon the hypothesis raised, actions were defined to contain the crater defect. The first action was to regulate the inflator shut-off valve so that more cold air was thrown into the flash-off. The second action was to regulate the exhaust shut-off valve so that hot greenhouse air would no longer enter the flash-off and no cold flash-off air would enter the greenhouse, which would decrease efficiency equipment and may cause other problems in painting. The plan has two actions and is described in Chart 3.

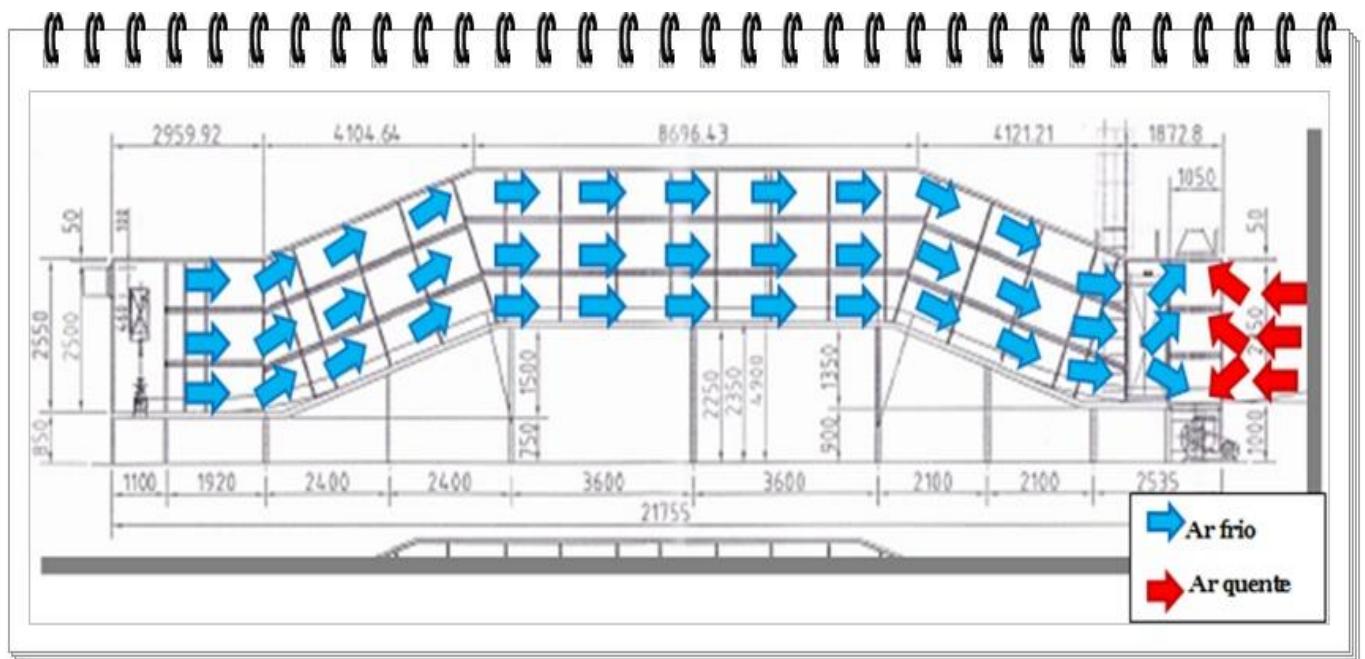
Figure 10: Check for new air balance in Flash-off.

With the planned actions, the flash-off and greenhouse air balancing were as described in Figure 10.

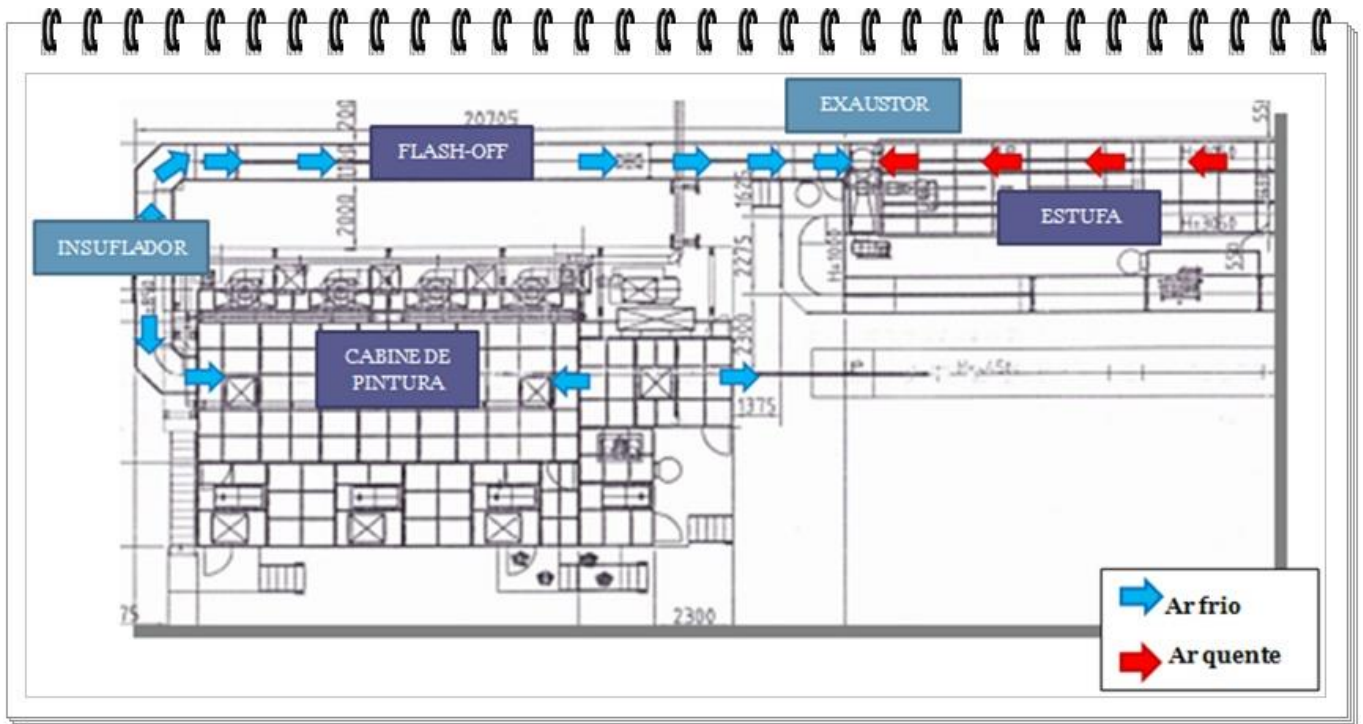
Figure 11: Verification of the new air balance in the Varnish Painting Process.

With the new balancing, it was found that warm greenhouse air no longer entered the flash-off and neither cold flash-off air entered the greenhouse, as shown in Figure 11.
