Headwather Recovery in Mindú Municipal Park: An Experience in Environmental Education

Abstract

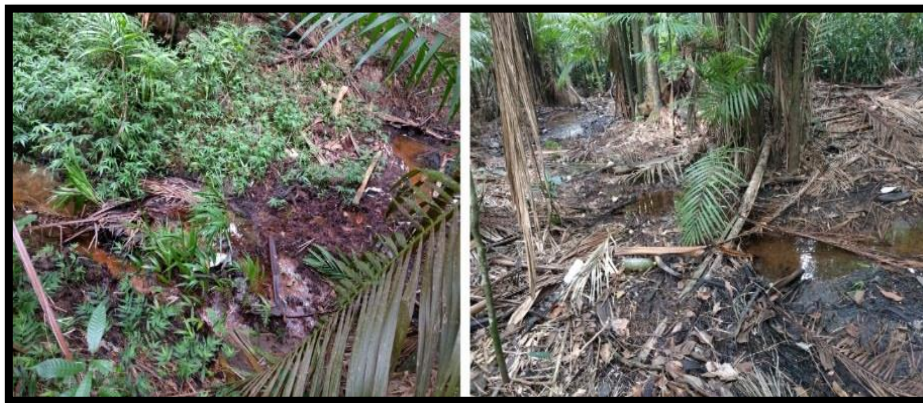
According to the observed scenario (Figure 2), the canal was clogged due to accumulated residues such as foliage, dry branches, sand and even urban solid residues, due to the expansion and thickening of vegetation and other natural components when they accumulate in a large amount of water they may obstruct it. causing him to look for other means of exiting the ground, changing the river flow.

Figure 2. Spring of Mindú Park with dry branches that obstructed the passage of water.

The actions were performed with the help of a shovel, hoe and wheelbarrow, removing the objects from the area and all the sediment that prevented the flow of water, the result after a few weeks was satisfactory, because a small course of water was reappearing (Figure 3).

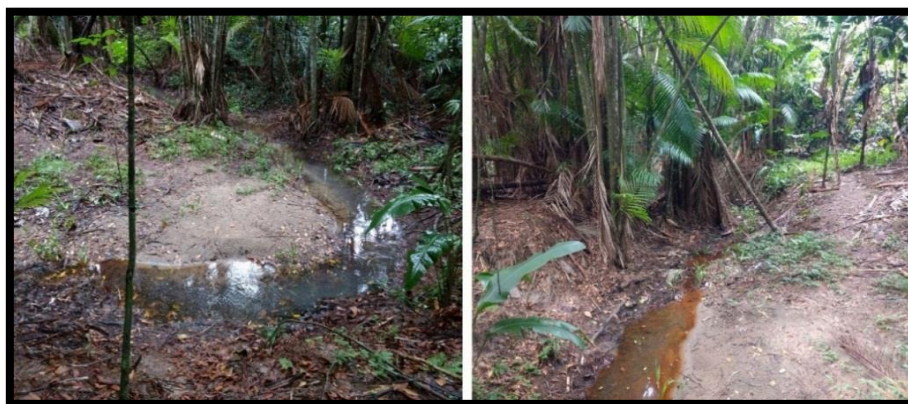
Figure 3. Clearance of the Nanuente of Mindu Municipal Park.

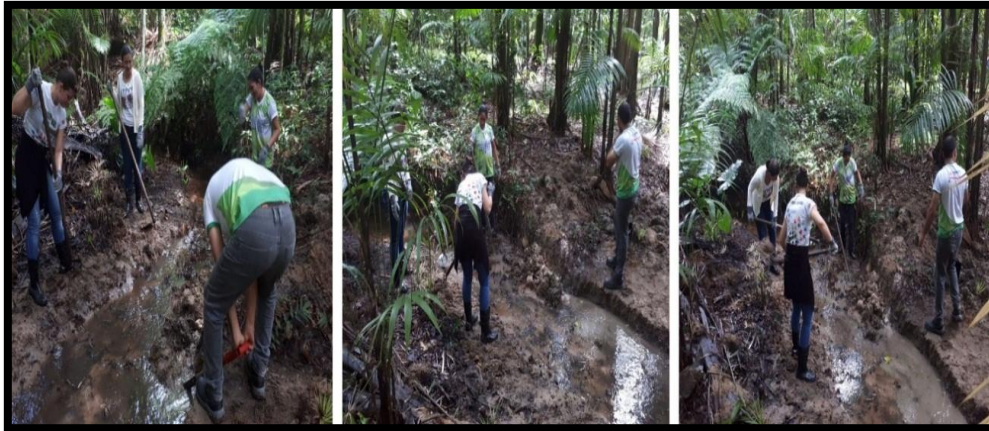
Following the course of the spring about 20 meters ahead, it was noted the accumulation of sand, which

causes siltation on the site. To prevent siltation from clogging the flow of water, they were carried out with the aid of tools to remove sand and make way for water to flow (Figure 4).

Figure 4. Siltation in the source of Mindu Park.

The purpose of removing the artery was due to the obstruction of the water channel. The canal sprouts elsewhere or closes at once. Therefore, from the sediment that obstructed the place where water sprouted (Figure 4), it was removed to keep the drinking fountain of the park active [11].

To prevent siltation, the presence of riparian forest is essential, that is, a natural protection against siltation. Without it, the erosion of the banks takes land into the river, making it muddy and making it difficult for sunlight to enter, also known as gallery forest, lowland forest, vegetation or riparian forest. Species were introduced in areas where siltation occurred.

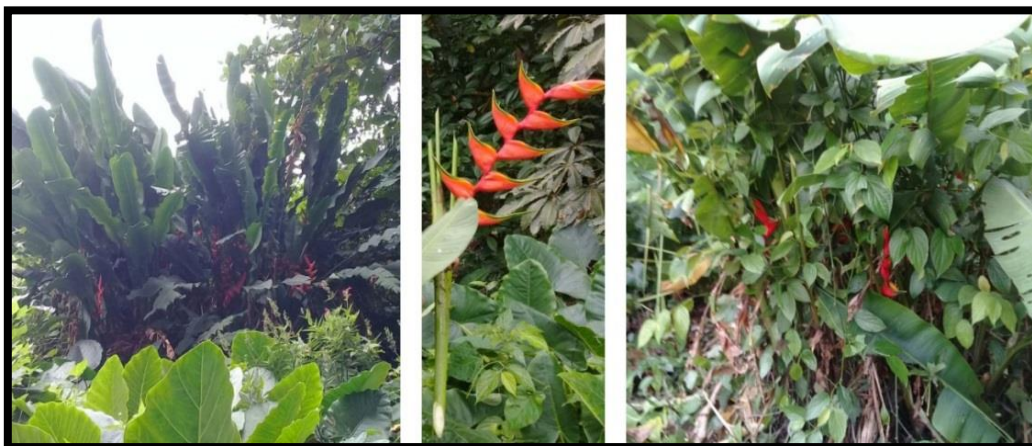
For application there was the use of species arranged on the ground, called Heliconia (Heliconiaceae), whose common name is caeté or banana tree (Figure 5) that bloom from September to February, the naturally occurring region are the states of Amazonas and Acre, especially in moist secondary and primary forests, on riverbanks, roadside and places with soggy soils.

Figure 5. Plant species arranged on site.

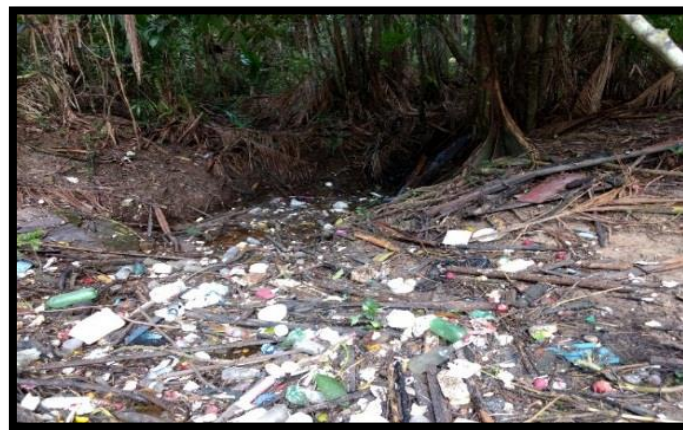
was observed that the site was abandoned and without any care. Before starting the restoration actions, it was necessary to evaluate the location, since it was an area closer to the Stream do Mindu, in this space were found different types of solid residues (Figure 6), due to the extension of the Stream do Mindu, these residues have been seeping through the aquifer that ends up being dumped in various neighborhoods of the city of Manaus.

According to Figure 6, the residues that were removed with the cleaning of the area were pet bottles, plastic bags, plastic packaging. Through waste bags were deposited all the waste that was in the area affected by pollution.

Figure 6. Floating solid waste in Mindu stream.

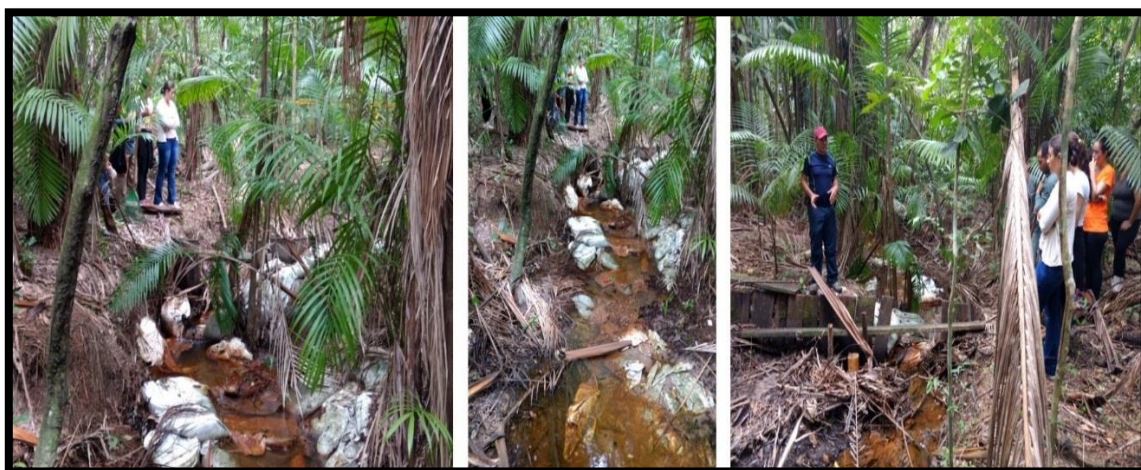
The intent to rebuild the containment was to ensure that the residues would not be dammed in the watercourse near the source path, but not by ensuring that, as the waste is deposited, it cannot cause the obstruction again (Figure 7). After cleaning the area, the dam was rebuilt using sandbags inside.

Figure 7. Construction of Mindu Park Containment.

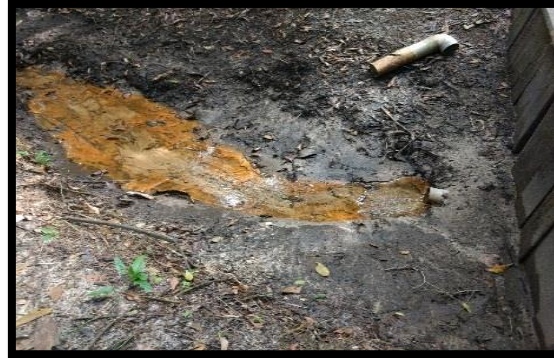
Near the ground, the 100 mm PVC pipe (Figure 8) was allocated, whose function is to clean the spring [7]. The pipe can be closed or open, and it is possible to control the flow of water without damaging the Mindu Park natural drinking fountain during the dry season, which occurs during the months of August, September, October and November, while the December to July are the flooding months of the rivers [12] [13].

Figure 8. Containment exhaust pipe.

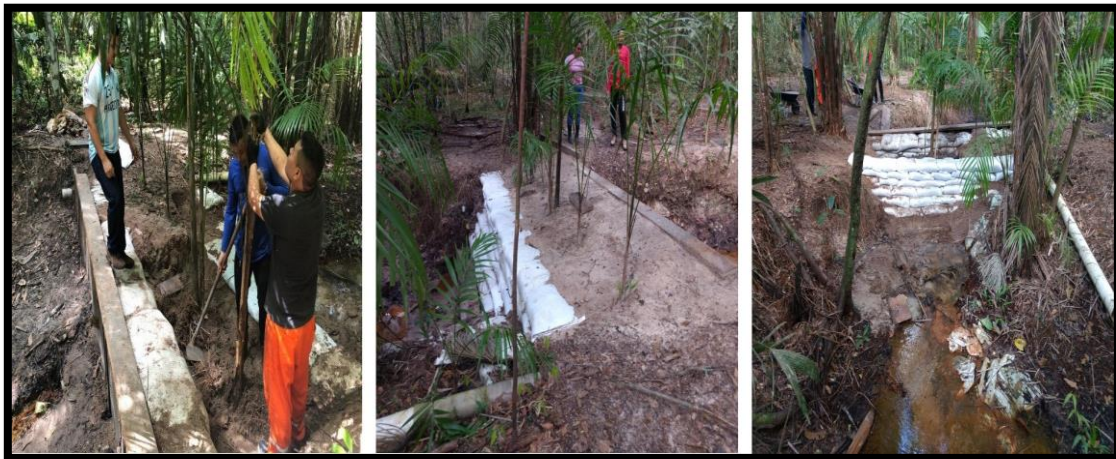
In the containment (Figure 9) 66 polypropylene bags with sand inside were used, creating a microfilter so that the water that comes out of the nascent and does not mix with the polluted water of the Mindu stream. The seedlings collected on site were planted on site improving the structural aspect and fixation of the soil and also highlighting the scenic beauty of the site.

Figure 9. Implementation of sandbags and planting of seedlings in containment.
