Air Conditioner Production Failure Analysis Techniques

Fernanda Yakushijin Gomes dos Santos; David Barbosa de Alencar; Alexandra Priscilla Tregue Costa; Marden Eufrazio dos Santos

Published Date: 10/31/2019

Vol 7 No 10 2019

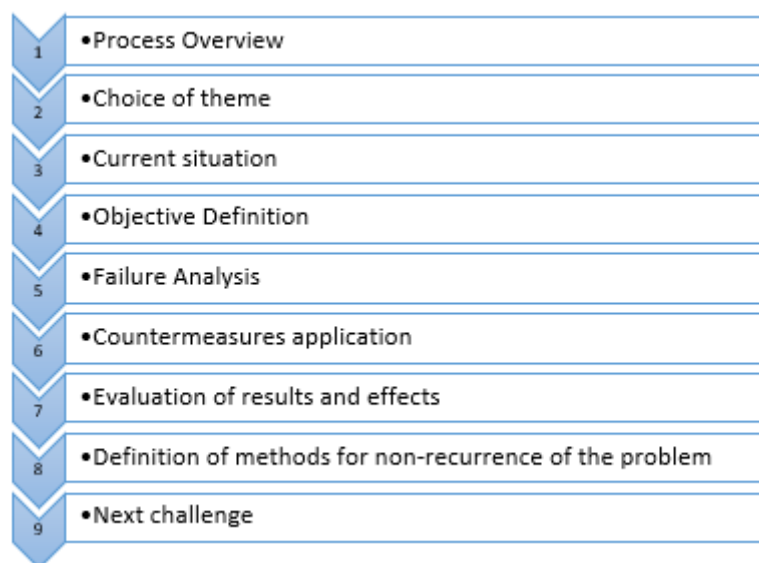
Figure 1 (Failure Analysis Flow)

A case study was done in an air conditioner company to reduce internal circuit board failure where it was done according to the following steps as shown in Figure 1. Steps are: 1) Process Overview, 2) Choice of Theme 3) Current problem situation, 4) Goal definition, 5) Factor factorial analysis, 6) Countermeasures application, 7) Results and effects assessment, 8) Defined non-recurrence methods and 9) Choice of next theme challenge.

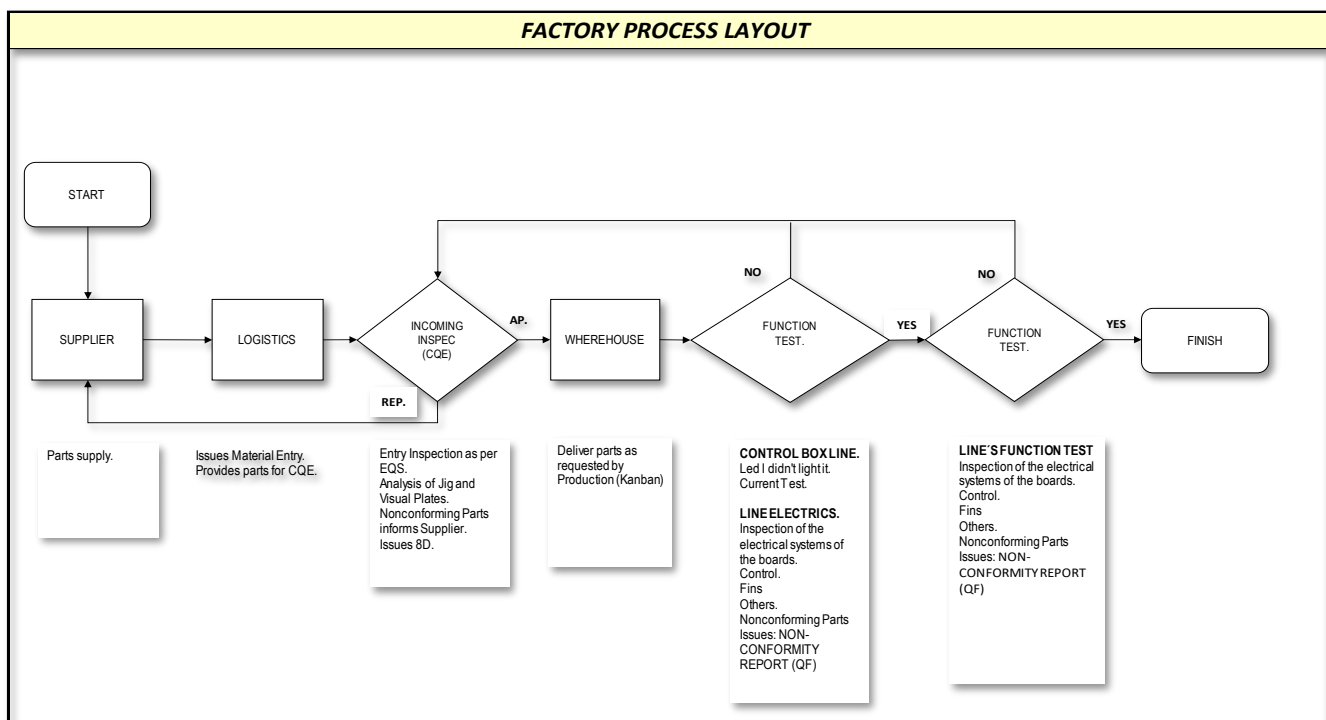
Figure 2 (FACTORY LAYOUT)

The layout factory process flow (figure 2) has the following process the product as soon as it leaves the supplier comes to the factory and is entered in the inbound inspection sector that checks some quality items according to the technical, dimensional and visual specification of the parts. and soon after they are released for storage and when requested by the productive sector that works as demand are delivered to the production where the electrical assembly is assembled passes the microprocessor functional test and is then assembled the other components of the conditioner together with the assembly. electric air conditioner and undergoes functional testing where the entire product is thoroughly tested to certify its operation.

process and we also had 2 plate assembly processes in our supplier which resulted in the layout we call factory layout (figure 2) which is the process of AC factory, SMD layout (figure 3) automatic plate processing and DIP layout which is the manual and plate testing process (figure 4).

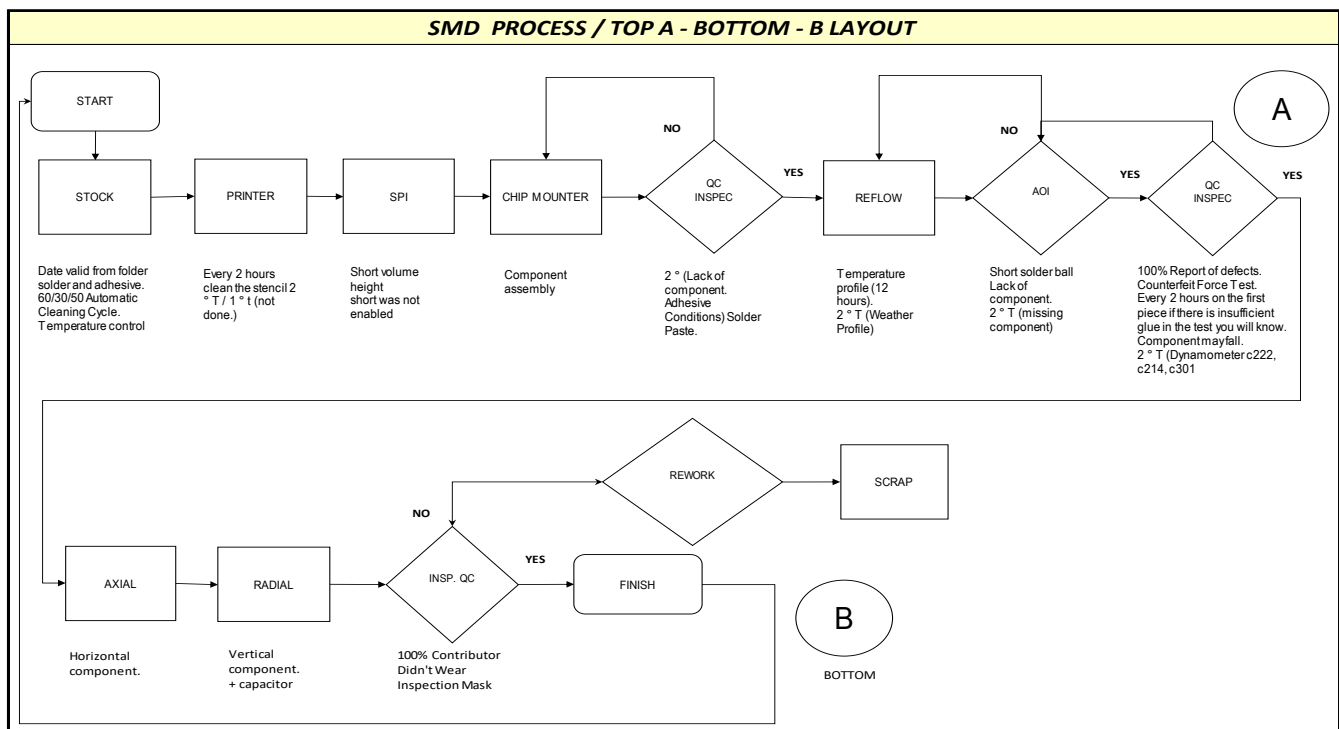
Figure 3 (SMD LAYOUT)

The flow of SMD processes (figure 3) goes through the stock with controlled humidity and temperature, goes through the printer a machine where the components are automatically placed in the unmounted pcb, when the components are inserted it must be added with a glue so that If the board on which we call the printer is stuck after this process the board goes through a machine called SPI that checks the volume of the glue and then the assembly of the chip then goes through the 1st inspection, the oven, the inspection 2 ° AOI a camera that checks the position of the components, if approved position will go through the visual inspection finalizing the process the top side of the board we call TOP, the bottom side process or bottom side some components that cannot be inserted by the top side are made to insertion by the machine called axial and radial passed by visual inspection so that it can go to the next process step (DIP).

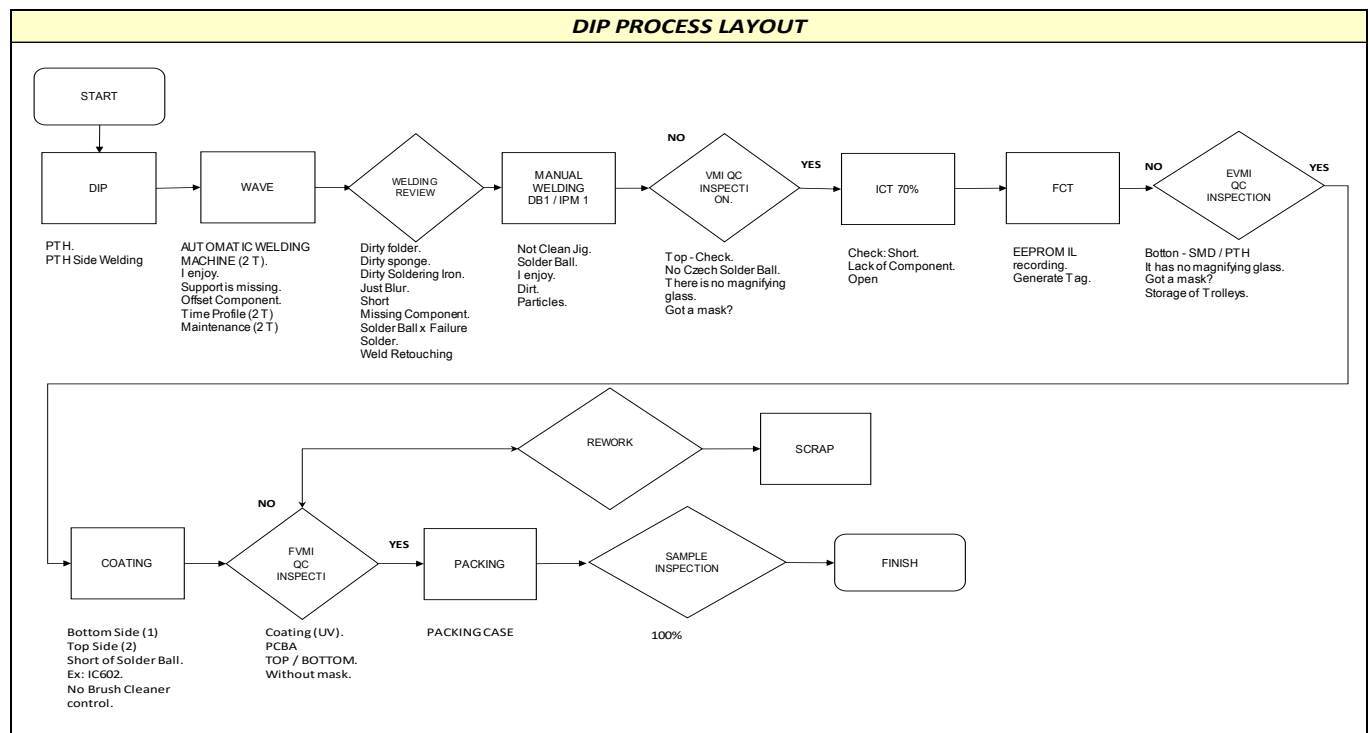
Figure 4 (DIP LAYOUT)

The DIP line flow process (Figure 4) is where the plate components that have been assembled on the SMD, axial and radial machines are finished, in this process step parts that cannot be inserted by machines are made manually by passing then by an oven that has melted solder paste welding the components, that glue that is passed on the printer serves to prevent the components from falling into the wave, the rectifier bridges are also soldered manually, presence testing of the components is done and then ICT The FCT undergoes functionality testing and its last step is that of protective coating which is handmade with a brush so that components and parts that cannot be sealed are protected using JIG for such activity.

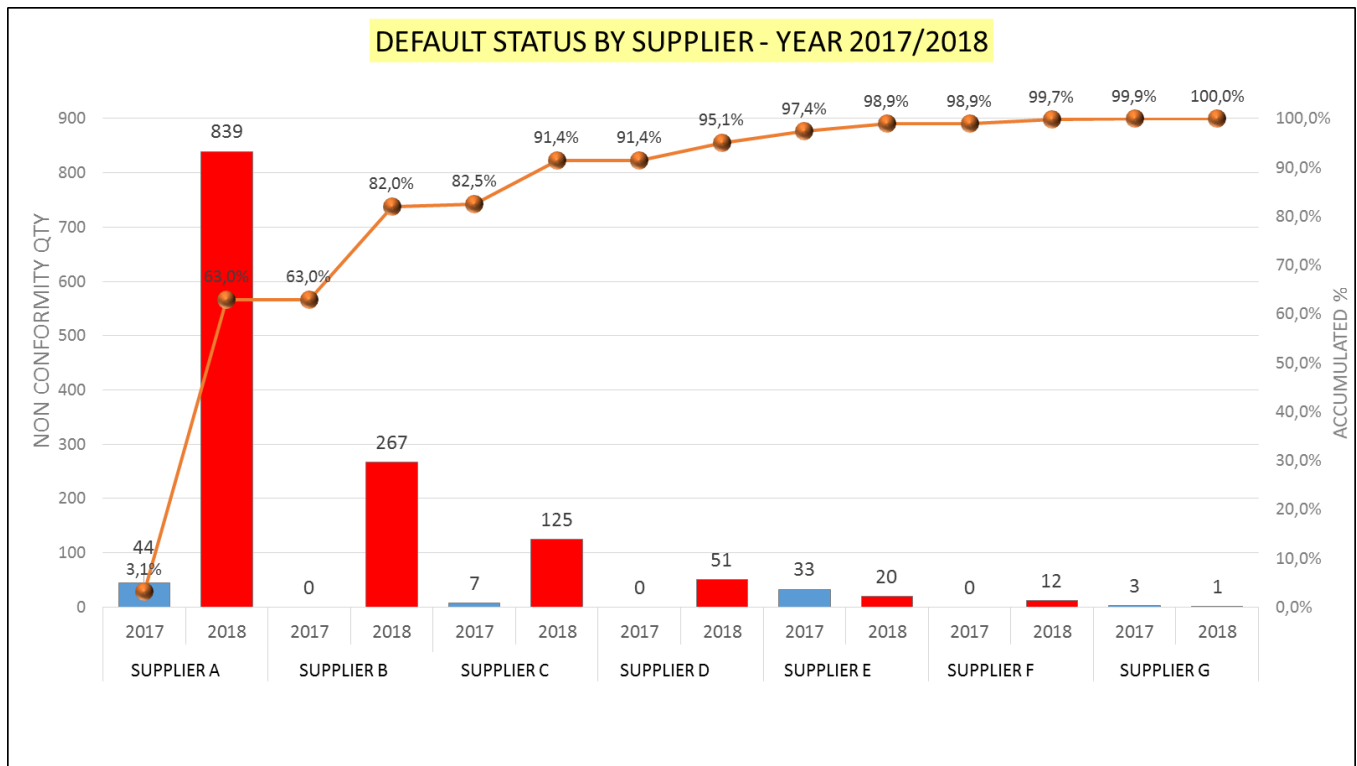
Figure 5 (Choice of theme)

As shown in figure 5 (Choice of theme) we can see were raised index data from suppliers A, B, C, D, E, F and G and from 2017 and 2018 and we can see that supplier A in 2017 represented 3, 1% of the defects in Pareto chart already in 2018 he had a very high nonconformity high going to 63% with 839 defect units and supplier B had zero defects in 2017 and 267 defects in 2018, in this first analysis we can see that supplier "A" had the highest defect rate in% and per unit of defects in 2018, so supplier A with the most nonconformities was the supplier chosen for problem analysis.

As we know that supplier "A" was the lowest performing and highest number of non-conforming suppliers in 2018 with 839 defects representing 64% of the chart, among these 839 defects there were 4 types of products that we will call Plate A with 679 nonconforming items representing 96.9% on the chart, Plate B with 65 defect items representing 99.9% on the Pareto chart, Propeller A with 95 defect items representing 99.7% of defects and Propeller B representing 100% of the chart.

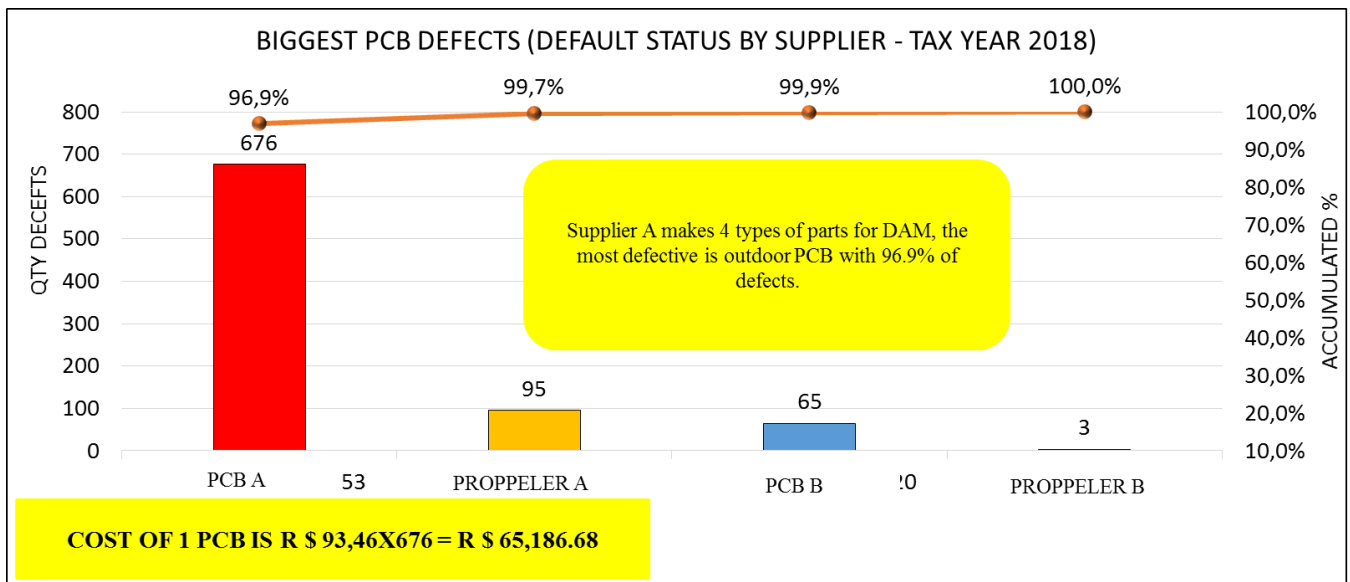
Figure 6 (Biggest PCB defects)

As in the current situation stage we must use graphs so that we can illustrate the scenario of the problem, was made the survey of defects by suppliers from 2017,2018 and 2019 until the month of February, so that we could know which was the supplier. underperforming, after knowing which supplier (A) had the worst result with 63% of supplier defects. We did a survey to see how many items he provided and we identified that were 4 items as (Figure 6) (Biggest PCB defects) May, of these 4 items we found that the PCB of the air conditioner outdoor unit had a higher rate than 96, 9% and after that we made a survey and made a Pareto chart to know what types of defects existed and further deepening the data identified that the defect that had the highest index was the non-compliance of the LED board did not light in the test. micon ID recording which had a higher Pareto chart index with 30.4% with 156 defect units following the IC out of specified with 55.6 %% with 129 defect units and 62.2% exposed copper and 65 units of nonconformities, the analysis and application of the defect analysis tools will be used on the largest defect Led Does not light.

ITEM	SUPPLIER A			
	PCBA	PROPELLER A	PCB B	PROPELLER B
QUANTITY PRODUCED	21658	29061	44850	22089
AMOUNT OF DEFECTS	676	95	65	3
PERCENT	3,12%	0,33%	0,14%	0,01%
ACUM %	96,9%	99,7%	99,9%	100,0%

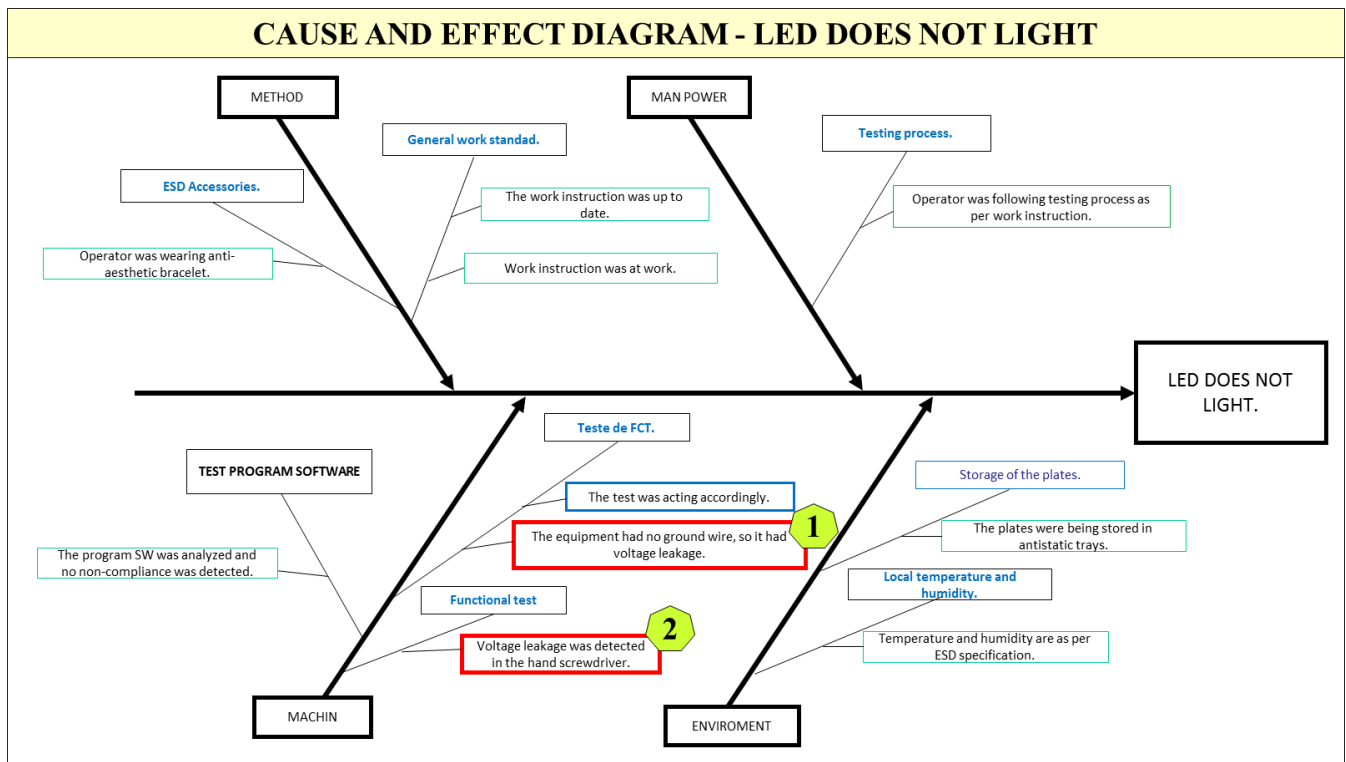
Figure 8 (Cause and Effect Diagram, Author: Fernanda Yakushijin)

In the factor analysis of the problem proposed for improvement was the part that we use the most problem analysis tools, in this step we use the brainstorm to raise all possible causes and effects after that we use the cause and effect diagram allocating all possible causes in its “M”, after drawing up the cause-and-effect diagram that was worked out together with the kaizen team of the quality industry factory with a group of 3 people from the supplier where we had quality, process and process engineering people, was Also defined in meeting which responsibilities of each member and dates for checking each cause raised during the survey we noticed that some problems were detected such as the lack of grounding in the functional testing equipment of the components of the board called FCT, was also evidenced. that in the factory process there was an ungrounded screwdriver, the red items While in the cause and effect diagram according to Figure 8, items with non-standard deviation, non-specific or undetermined, items in blue and green are items that conform with no anomaly found.

The nonconformities found were analyzed and dealt with as shown in Figure 9 below two nonconforming items and one item verified nonconformity are in the image, the functional test grounding and the ungrounded screwdriver both processes were installed grounding and subsequently met to specification and The recording confirmation of the functional test program was confirmed by daily checklist with quantity produced vs. quantity of recording records checked on the equipment computer if the tested quantities were the same as those recorded on the test computer.

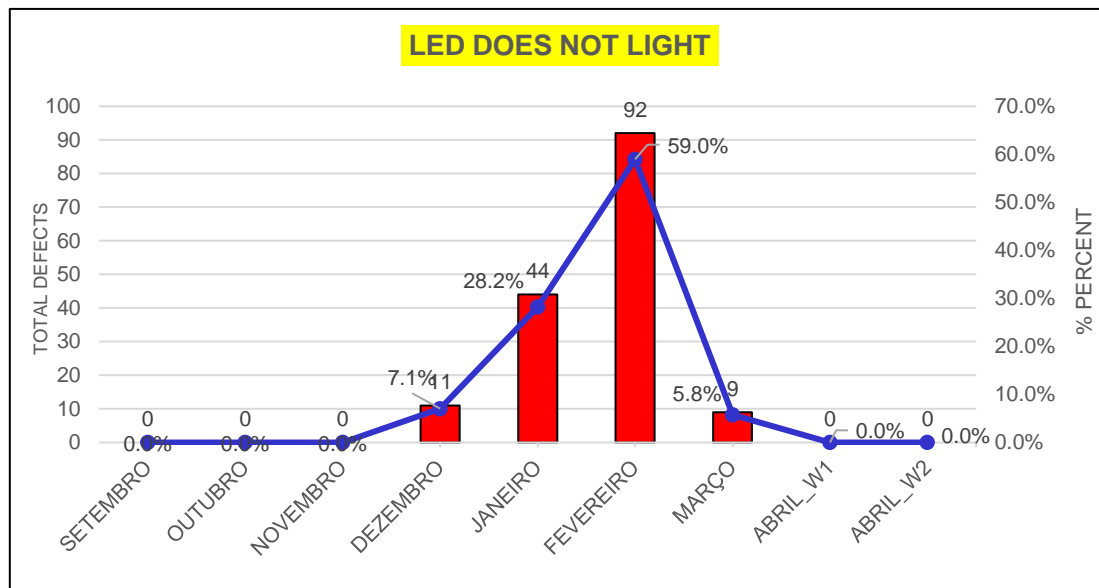
Figure 10 Results Led does not Light

Our results obtained as shown in (figure 10) were where we had a reduction of 156 LED defects does not light up to zero defects equivalent to 100% after the improvement, in December we had 92 nonconformities in March nine and the first two weeks of. April after improvement we had zero defects during the post-implementation effectiveness check period.

In order to be sure that the problems did not recur, some rules, procedures, standards and specifications were created for everything that was found out of place and also what was pointed out as a cause or potential point avoiding a possible future problem for these definitions. a plan using 5W to define the responsibilities of each item pointed out until status verification.
