Geotechnical Characteristics of Mass Movements in Manaus – AM

Abstract

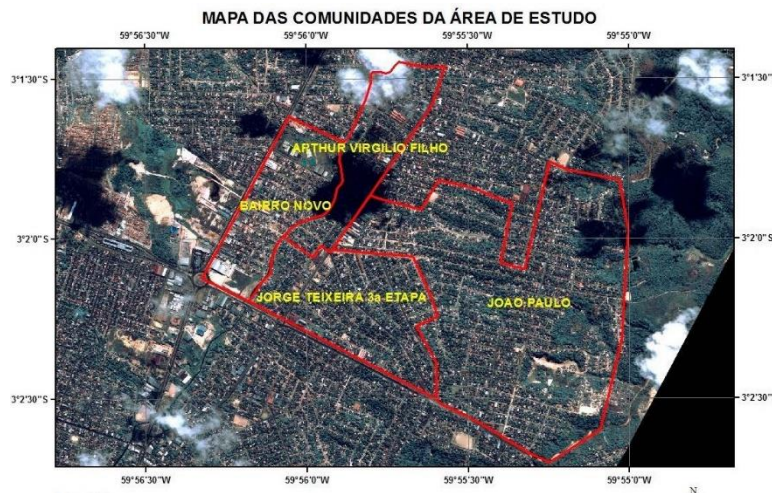
Figure 2. Map of the region under study.

The characterization of the risk areas, in addition to the “office” surveys, was carried out through field investigations, the surface was verified and the natural and / or anthropogenic conditions that could induce sliding processes were identified. The five slopes examined were selected according to their risk classification by the Brazilian Geological Survey in partnership with the Civil Defense, in 2012. Figure 3 shows the location of Jorge Teixeira neighborhood, in relation to Manaus, and the five research areas (Slope I to V).

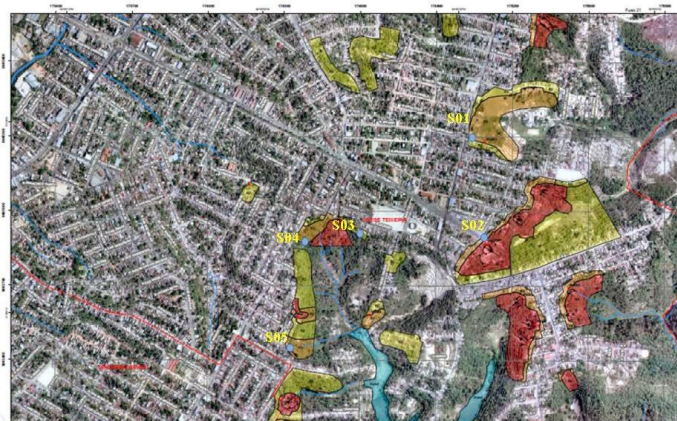
Figure 3. Risk classification map, Bairro Jorge Teixeira, Manaus - AM.

Hillside	Rating
S01	R3 - High
S02	R4 – Very high
S03	R2 - Medium
S04	R3 - High
S05	R3 - High
