Analysis of The Current Situation of Irregular Dwellings in The Black Land Neighborhood of Manacapuru-Am: Causes and Consequences

ABSTRACT

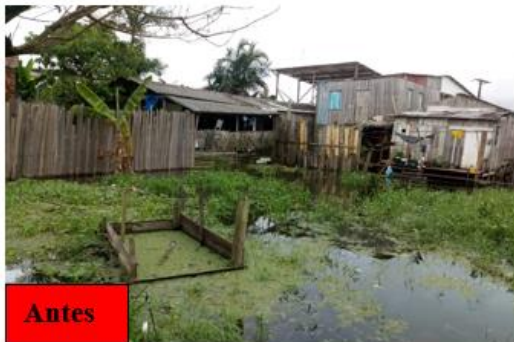
Figure 2: Flooded houses during floods.

Therefore, from the information described in the master plan of Manacapuru / AM it was possible to detect in loco the basic characteristics for the identification of land use and occupation from the current laws and the typology used based on art. 54 described in Table 1, which facilitated the identification of a variety of irregular occupations in the Terra Preta neighborhood, such as: occupation in flooded or flooded land, land in protected areas, in land with slopes equal to or greater than 30%, on land where geological conditions do not advise the building, shown in Figures 2,3,4 and 5.

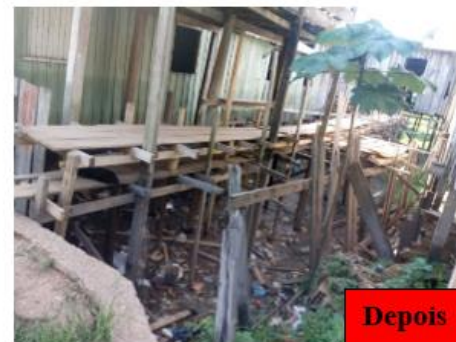
Figure 3: The houses after the flood.

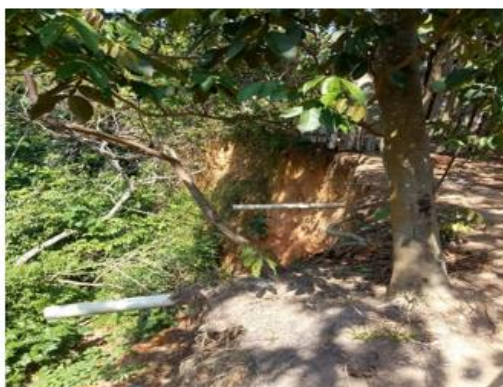
Figure 4: Terrain with slope greater than 30%.

Area near the steep slope, are over 30 m high, and high slope in several stretches, where houses are a few meters high on the slope.

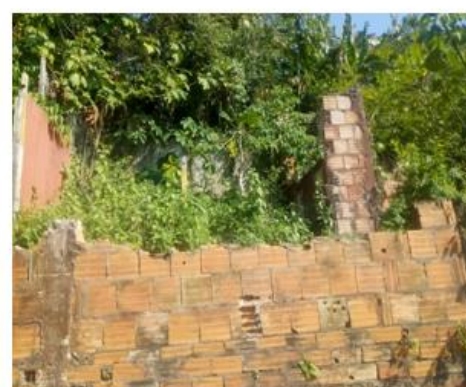
Figure 5: House destroyed by ground mass movement.

In October 2010, according to CPRM, three children died due to a large rotational landslide that hit some houseboats, several regional boats and canoes. In March 2017, civil defense relocated the population affected by a landslide in the black earth district on the riverside street leading to the deaths of some residents (Figure 6). Due to this disaster, the municipality declared an emergency situation in March. This natural event was recognized by the Federal Government, and families who had their homes destroyed received relief until their needs returned to normal, totaling 41 families who had their homes invaded by land and currently the affected are on paid social rent. by the City Hall of Manacapuru.
