Technological Control Assessment and Concrete Receiving

Abstract

International Journal for Innovation Education and Research

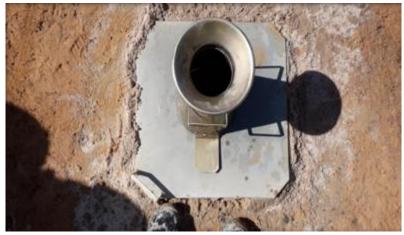
According to NBR [7], with the material already prepared and the wetted plate (Figure 1), the cone is filled in three concrete layers, in each layer with application of 25 strokes in a distributed way, each layer is thickened from the As even as possible with the distribution of the strokes, causing the rod to penetrate approximately 20 mm from the previous layer, the technician has 5 to 10 seconds to lift the cone, according to item 5.3 of the aforementioned standard.

Figure 1: Cylindrical cone and wetted plate Source: Enterprise X, 2019.

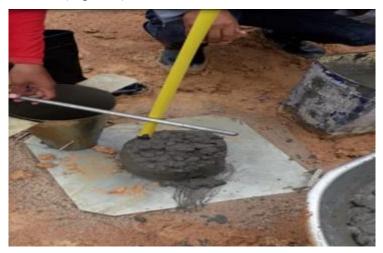
The technician then positions the rod over the inverted cone to verify the distance between the sample height and the bottom of the rod (Figure 2).

Figure 2: Checking the sample height Source: Enterprise X, 2019.

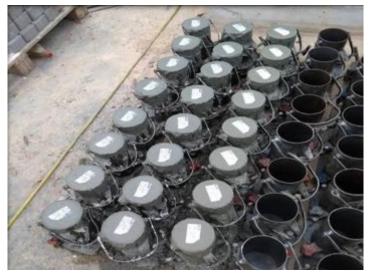
After molding, specimens (Figure 3 and 4) were identified for the compressive strength test at 24 hours, 7 days and at 28 days.

Figure 5: Identified Bodies Source: Enterprise X, 2019.

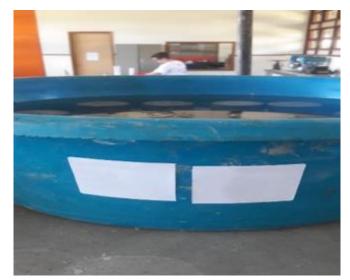
Upon arrival at the laboratory the cores were dipped into the cure tank (Figure 7) according to NBR [14].

Figure 7: Aged specimens Source: Laboratory Z, 2019.

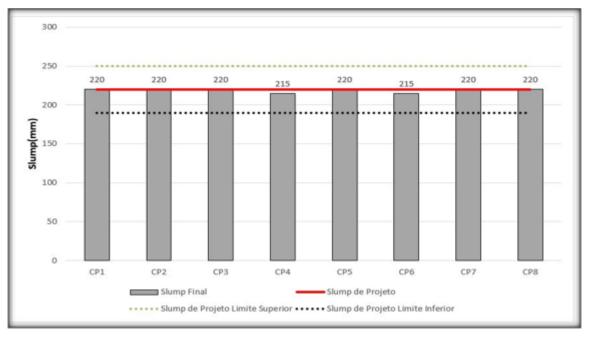
process. Figure 9 presents the comparative result between the Final Slump, obtained in the field for each concrete sample, and the Project Slump.

Figure 9: Final Slump vs. Project Slump Source: Prepared by the Authors, 2019.

From Figure 9, it was found that the Slump data obtained for each sample are within the upper and lower limits, as projected, the arithmetic average was 220 mm which is the exact value of the stipulated for the project. According to the parameters determined in ABNT NBR [6] and ABNT NBR [1], the procedure used by the work with regard to the acceptance of fresh concrete was considered satisfactory in this research.
