# **INLET CROSSING INSPECTION IN URBAN WAY BASED ON ROAD SAFETY FACTORS.**

## **Abstract**

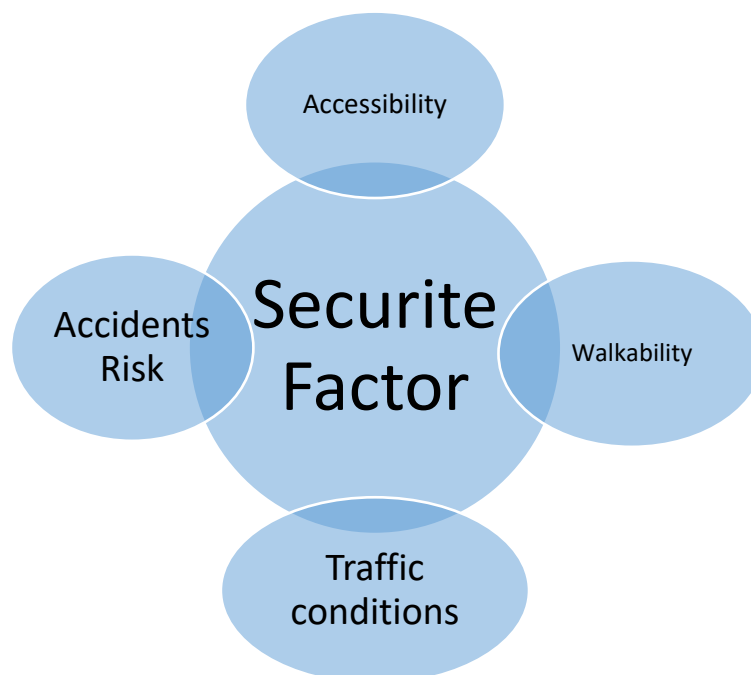
Flowchart 1. Securite Factor.

The conditions that make up the safety factor are expressed according to flowchart 1.

The conditions that make up the safety factor have been inspected according to the principles of the user's needs.

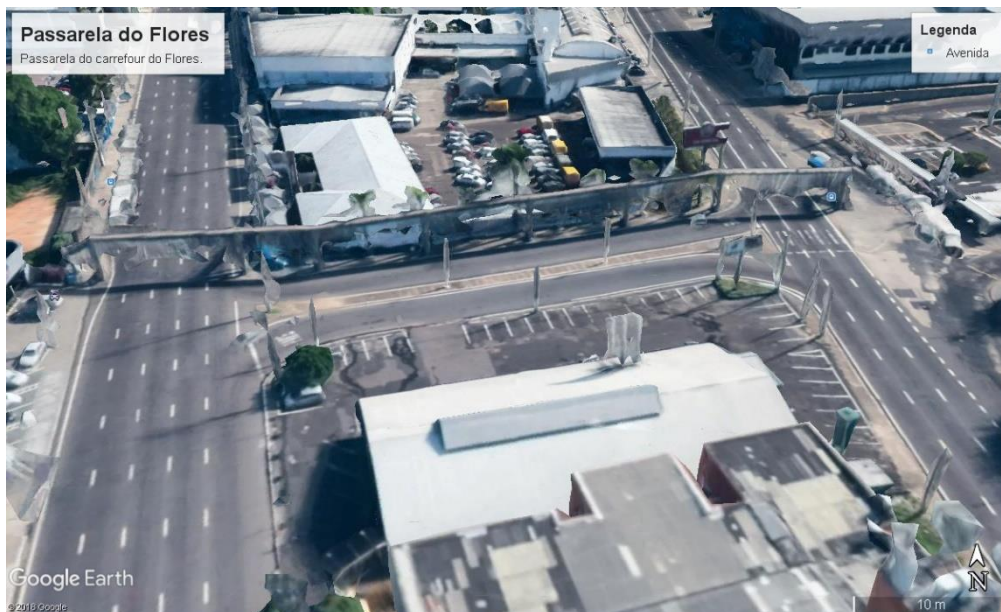
Figure 1. Location of the crossing. Source: Google Earth Pro.

Pictures 1,2 and 3 show the condition of the current catwalk scenario, it is notable that the catwalk undergoes some renovations in part of its infrastructure.

As shown in figure 1, the walkway is approximately 102 meters long, with two accesses on both avenues. In image 2 it is possible to analyze the walkway in another perspective of access, made the analysis through another angle it is possible to make the necessary necessary recommendations later.

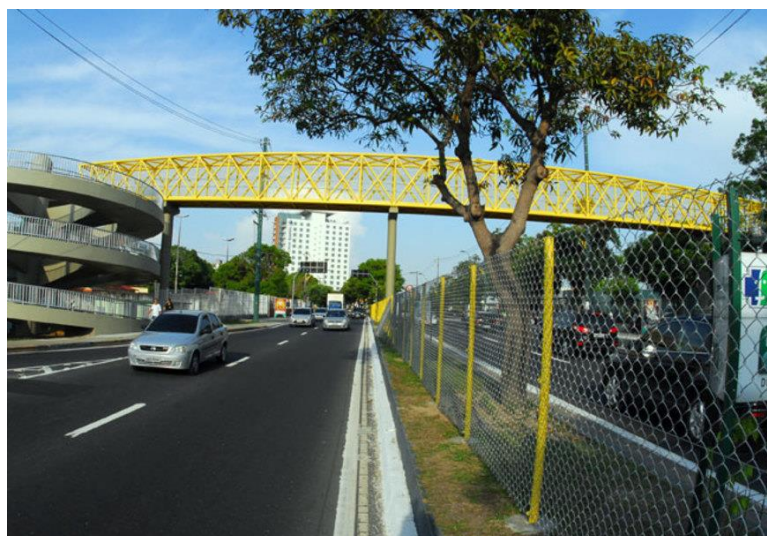
Figure 4. Footbridge Amazonas Shopping. Source: Acrítica.com

In Manaus, some walkways are distinguished by good accessibility, a few kilometers from the object of study, the walkway that connects a bus stop to a shopping center, accessibility was valued differently, elevators were not installed, but wide corridors were made , as shown in image 4.
