# Evaluation of the replacement of commercial coarse aggregate by *Attalea funifera Martius* (Piaçava) in concrete manufacturing

Bachelor of Civil Engineering

Estacio do Amazonas College – Brazil

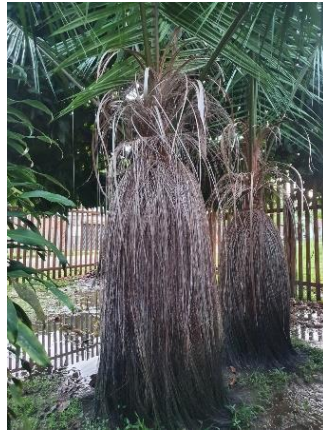
Figure 1. Piaçava.

*Attalea funifera* Martius, commonly known as piaçava (Figure 1), is a solitary, thornless, erect, caulescent palm from the *Aracaceae* family. It reaches an average height of 8 to 15 meters with a stem diameter of 20 to 25 cm, having 8 to 10 leaves, each 9 meters long. Piaçava, as it is popularly known, is a plant native to the southern region of Bahia, and can also be found in other regions of Brazil and the world. Its name originates from the Tupi language which means 'fibrous plant' [4].

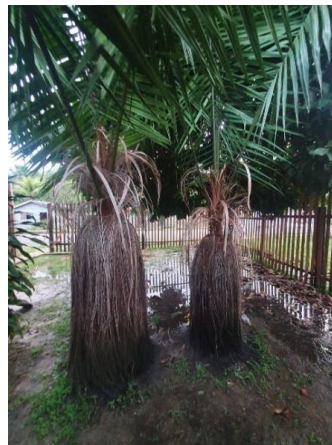
Figure 2. Young piaçava.

Piaçava receives different names throughout its development. Until the age of 3, it is called Patioba; from 3 to 12 years old, it is called banana tree and it is at this time that piaçava fiber production begins (Figure 2); from 12 to 15 years, young coconut tree, where it reaches its maximum in height, making it difficult to extract the fiber; and after 15 years it is called old coconut tree, and in this phase the production of the fiber begins to gradually decrease, however up to 50 years it is still possible to extract it [4].

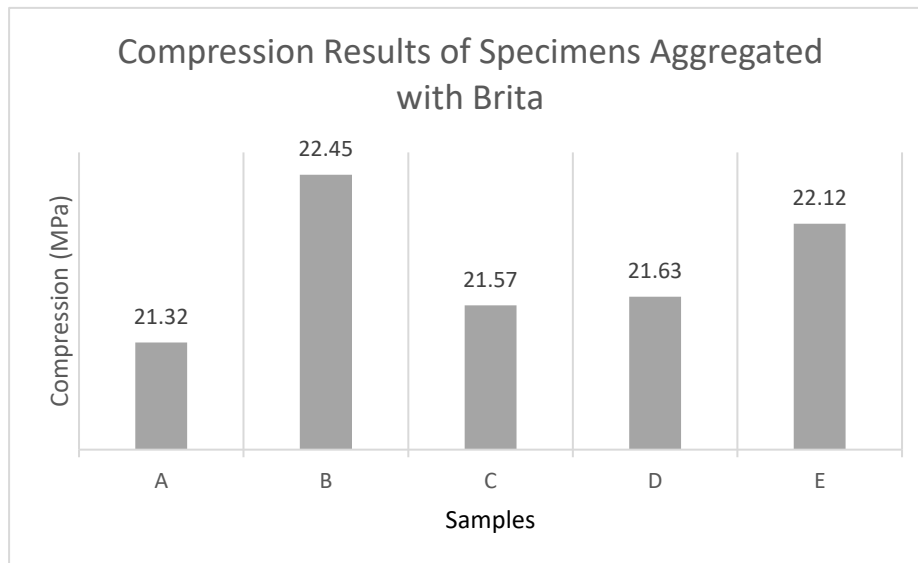
Figure 6. Compression results of aggregated concrete with gravel.

In figures 6 and 7 we can easily observe the compression results obtained for each group of specimens. The specimens that most resisted compression were B (aggregated with gravel) and H (aggregated with piassava), which presented, respectively, compression results of 22.45 MPa and 20.03 MPa. These results are very close, which indicates a great possibility of using piaçava sludge as a more profitable option for replacing commercial aggregates.

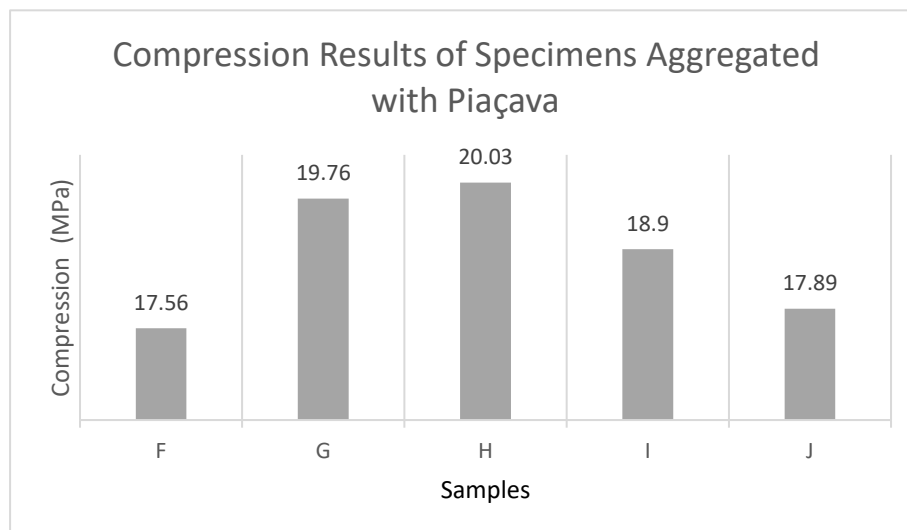
Figure 7: Compression results of aggregated concrete with piaçava.

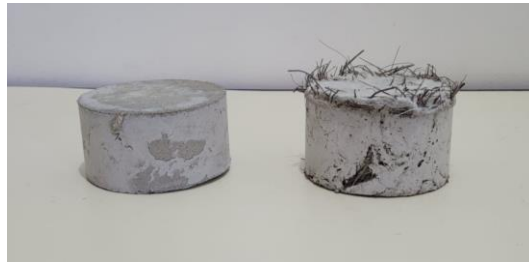
Figure 8. Specimen Models.

However, during the compression tests, we observed that the specimens prepared with piaçava had a much lower quality of appearance compared to the specimens prepared with gravel. We can visualize such characteristics in Figure 8, where we see that the specimen on the right (piaçava aggregate) presents a brittle appearance, empty spaces and deformities in its structure, while the specimen on the left (gravel aggregate) presents its structure complete and without flaws or voids.

According to that, we can attribute that the lower compression results for the specimens prepared with piaçava are due to the fact that the structure of the specimen presents structural flaws, deformities and failure in the adherence of the fiber in the cementitious matrix (Figure 8). Similar behavior was obtained in studies using fiber and reinforcement of industrial residues of copolymers such as EVA (ethylene-vinyl acetate) [1]. [10] we see that this characteristic of fragility of the material plus natural fibers is repeated, also affecting the results of resistance to tension and elongation and we can also notice that the amount of fiber added is again

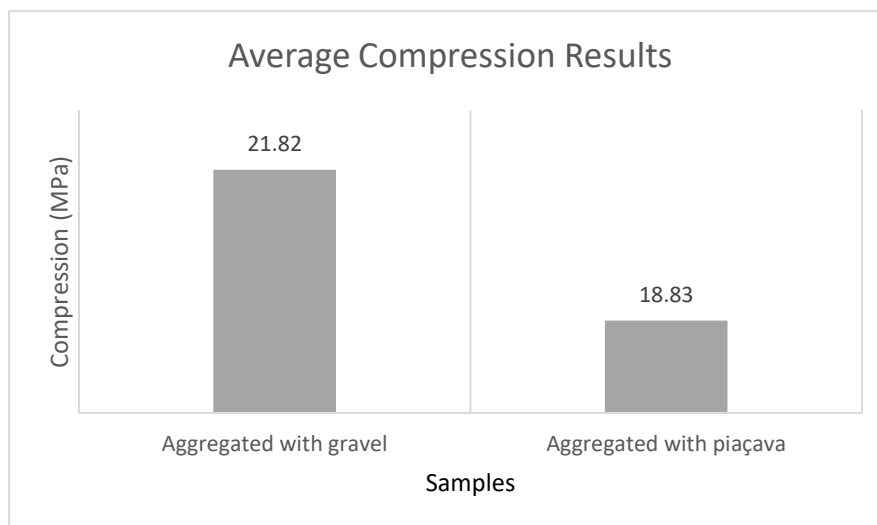
Figure 9: Comparison of the average compression results of the two types of concrete.

In Figure 9, we have the comparison of the average of the compression results obtained for each evaluated composite, we can see, in this way, the disparity of the compression results. In fact, the most important aspect in the results obtained was the structural deformation suffered by the composite added with piaçava. We can discuss the need to carry out future studies with the evaluation of different composition proportions of piaçava as well as the possibility of chemical treatments of the fiber surface that allow a better adhesion at the fiber/matrix interface, such as, for example, the study carried out by [11].
