How to reduce craters in the painting process of a PIM company?

Dept. of Industrial Engineering, Federal University of Amazon (UFAM)

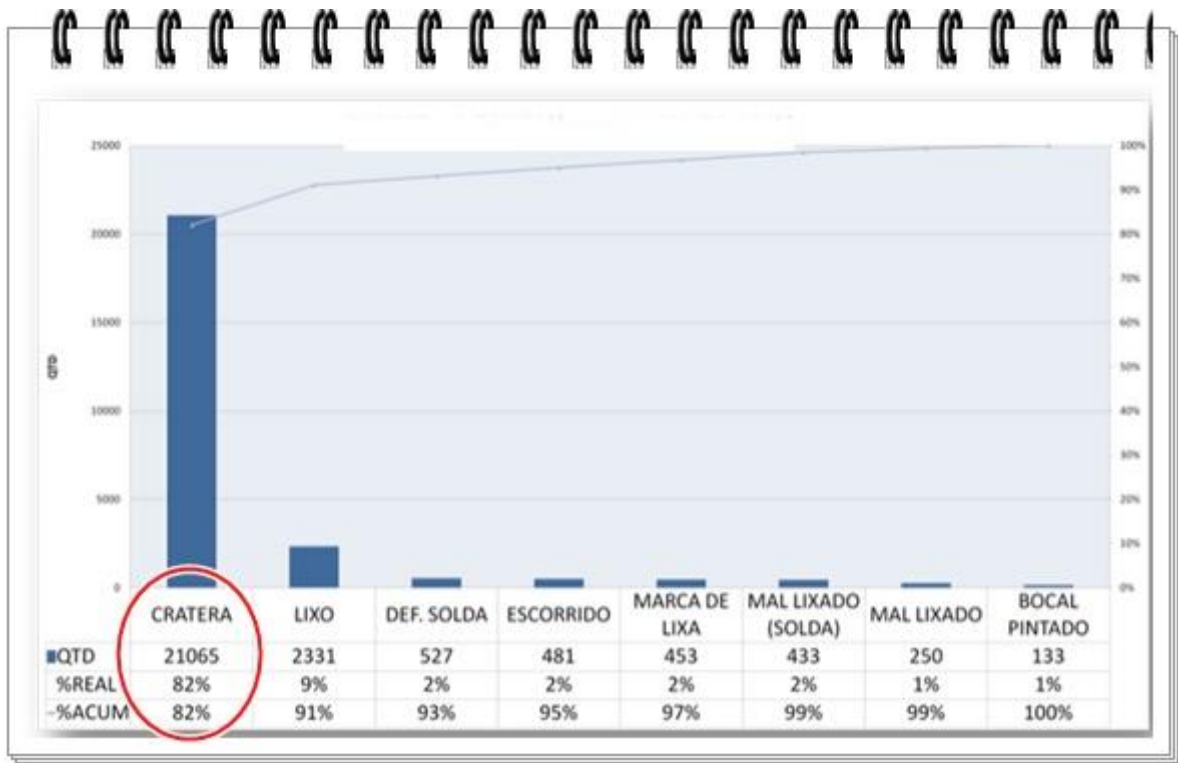
Figure 4: Q Number of Tank Painting defects in February 2012.

The choice of the crater defect as the main defect to be studied was made from the analyzes in the sector that showed that this defect corresponded to the highest index among all problems, as shown in Figure 4, with the Pareto graph of Tank Painting defects of February 2012.

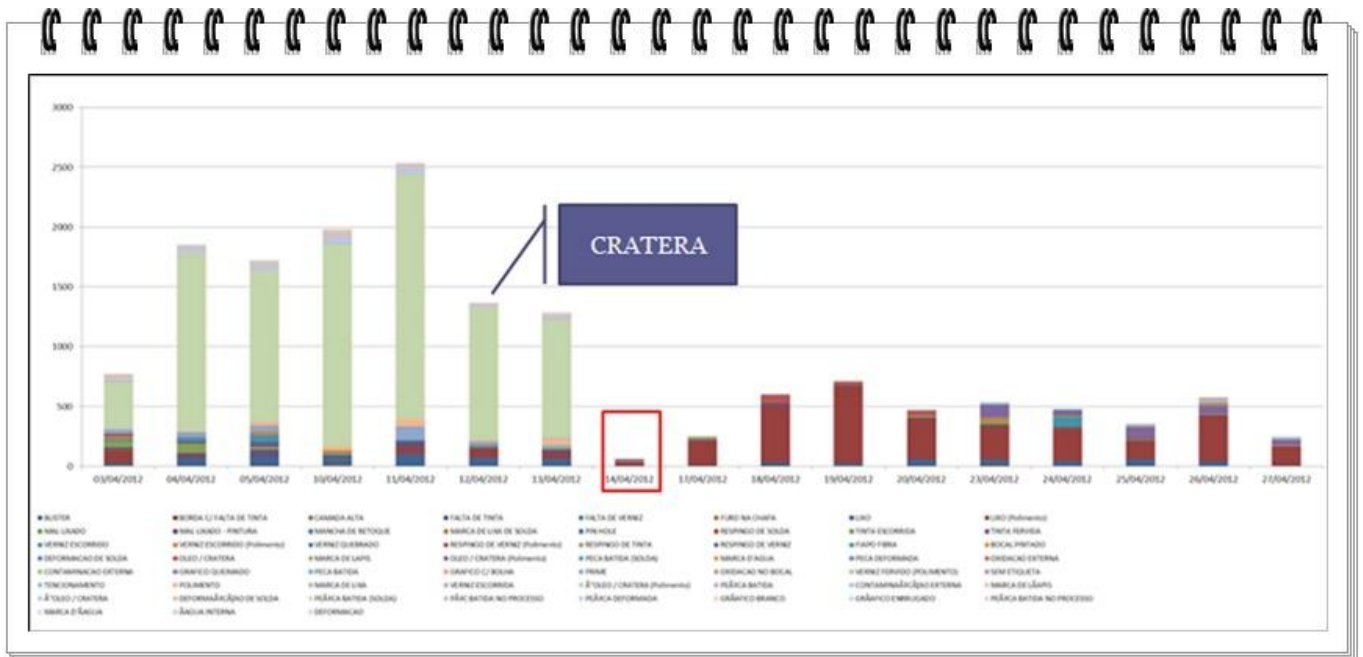
Figure 12: Tank Paint defect index in April 2012.

Analyzing the production data of the Varnish Line on the days following the actions performed, it was observed that the crater defect no longer appeared among the largest defects of the Line (Figure 12).

Upon the hypothesis raised, actions were defined to contain the crater defect. The first action was to regulate the inflator shut-off valve so that more cold air was thrown into the flash-off. The second action was to regulate the exhaust shut-off valve so that hot greenhouse air would no longer enter the flash-off and no cold flash-off air would enter the greenhouse, which would decrease efficiency equipment and may cause other problems in painting. The plan has two actions and is described in Chart 3.
